NASA Contractor Report 178246

Test Results for Composite Specimens and Elements Containing Joints and Cutouts

P. T. Sumida, R. C. Madan, and A. V. Hawley

Douglas Aircraft Company
McDonnell Douglas Corporation
Long Beach, CA 90846

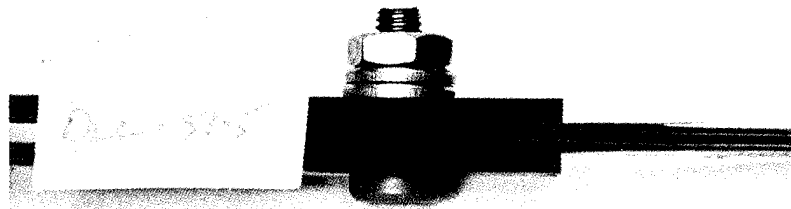
Figure 5-11. Typical Failure of Narrow DLC Specimen (Lay-Up No. 2)

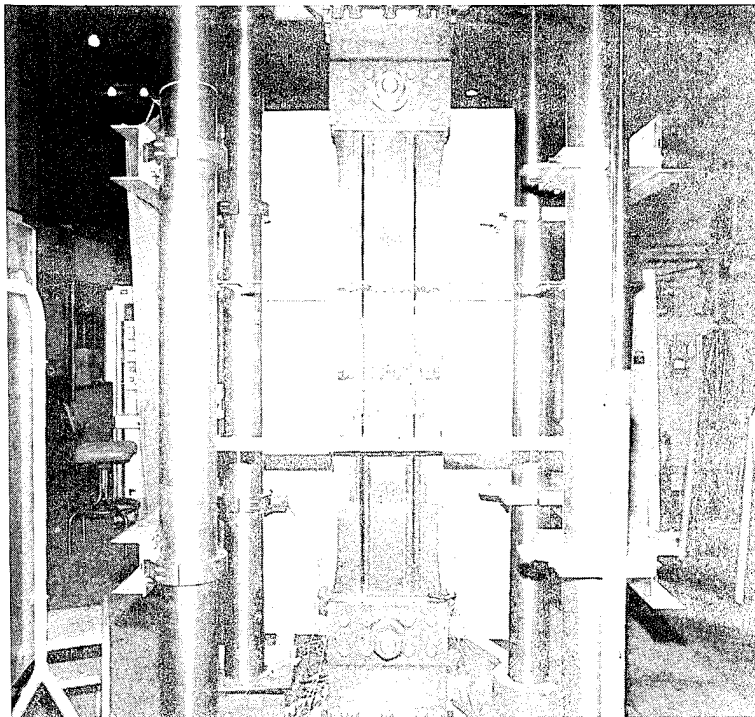
Figure 5-38 shows the compression panel during testing at roughly limit load with the skin buckling evident just “outside” of the splice bay (above and below the simulated frame supports).

Figure 5-38. Longeron/Skin Splice Panel (Compression Specimen) Under Load

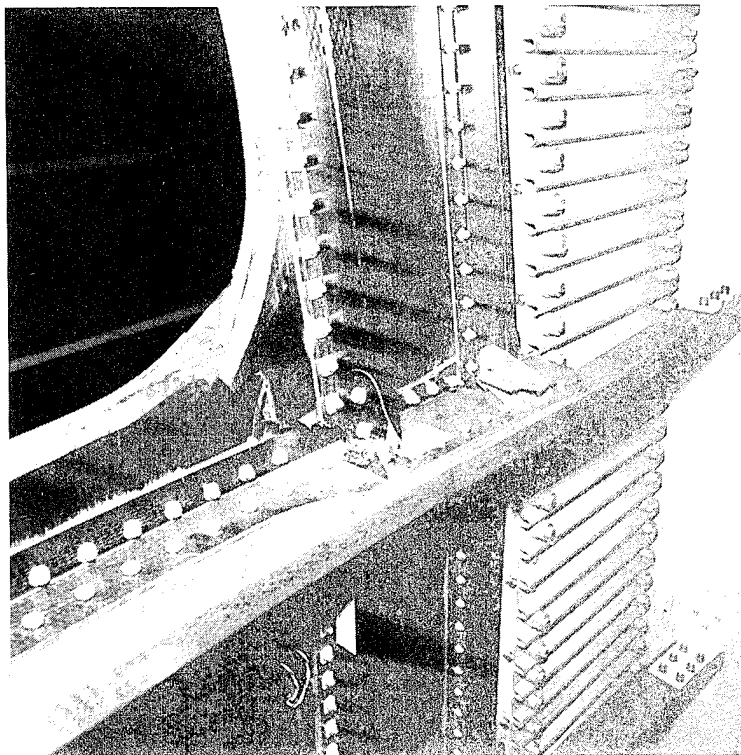
Figure 5-48. Group D Window Belt Panel — Failure of Skin, Longerons, and Frame
